U.S. Army Corps
of Engineers
New Orleans District

**PATTERNS OF CHANGE IN PLANTATION
LIFE IN POINTE COUPEE PARISH, LOUISIANA:
THE AMERICANIZATION OF NINA PLANTATION,
1820 - 1890**

FINAL REPORT

R. Christopher Goodwin & Associates, Inc.
5824 Plauche Street
New Orleans, Louisiana 70123

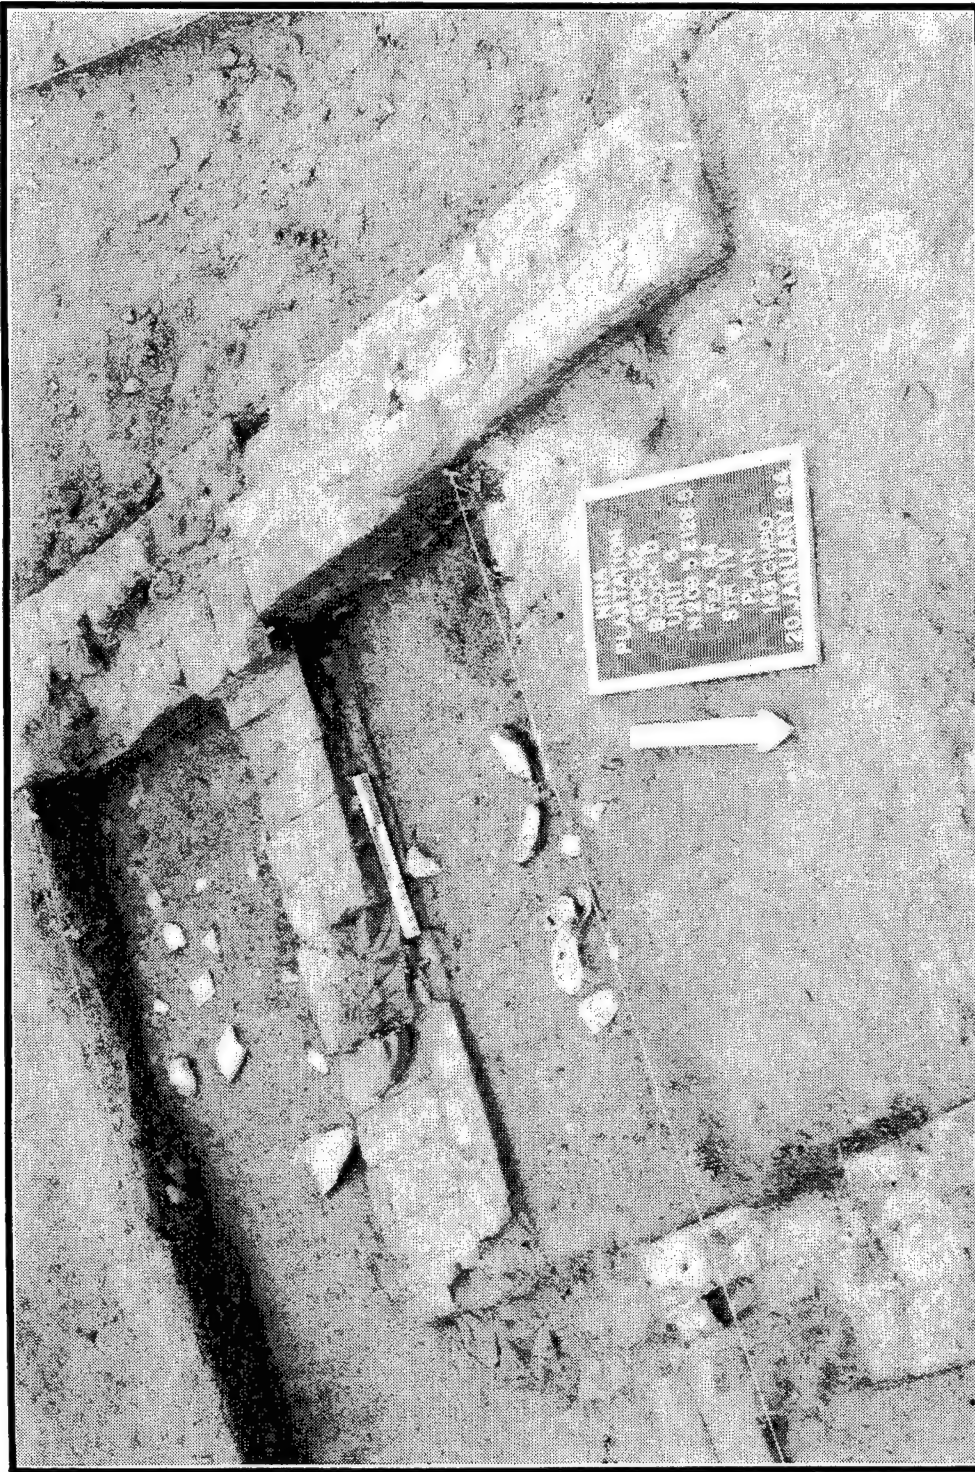
Figure 92. Brick chimney foundation (Feature 84) in the south wing of the Main House. Block D, Unit D/6.
